Re: Dodge Avenue Water Line, City of Evanston, Illinois

EXHIBIT B – SUMMARY OF 2014 AND 2014 WORK

EXHIBIT B-2: PHOTOGRAPHS OF THE UNIDENTIFIED 24-IN PIPE ENCOUNTERED DURING 2015 WORK

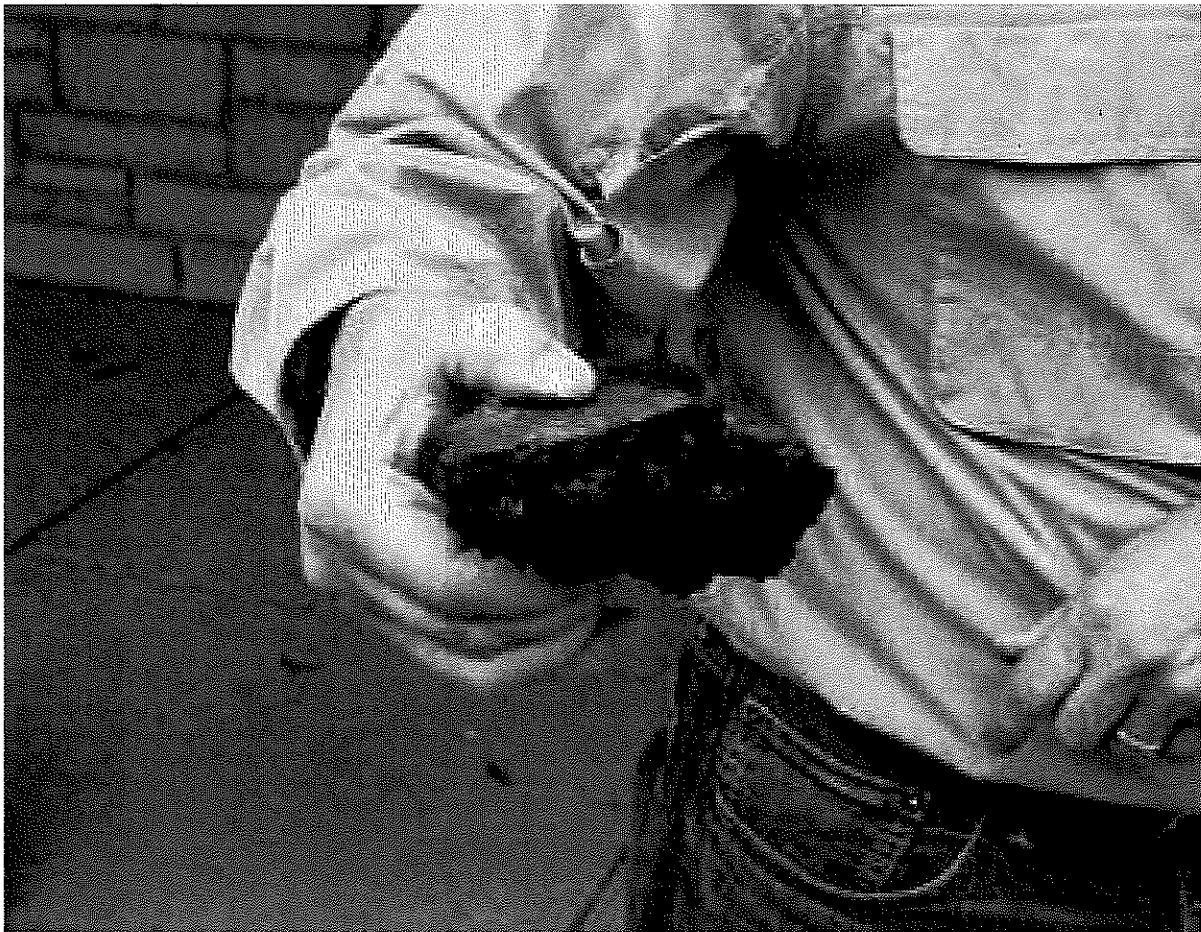
Figure 5. Photograph of Crust Sample Taken From the Water Pipeline

Mr. Bartus indicated that the water line along Dodge Street is encrusted with a relatively thick layer of dark brown to black material that has to be removed to allow for repair of the water line. This crust material is shown in the photograph on **Figure 5**. The thickness of the crust material on the pipe is typically varies from about 2 to 4 inches along Dodge Street. SCS took a sample of the crust material for analytical testing (see laboratory reports in **Appendices B-2 and B-3**).

The pipe encrustation was approximately 2.5 inches thick, as shown in this photo. Upper, smooth surface (under thumb) was in contact with the water pipe.

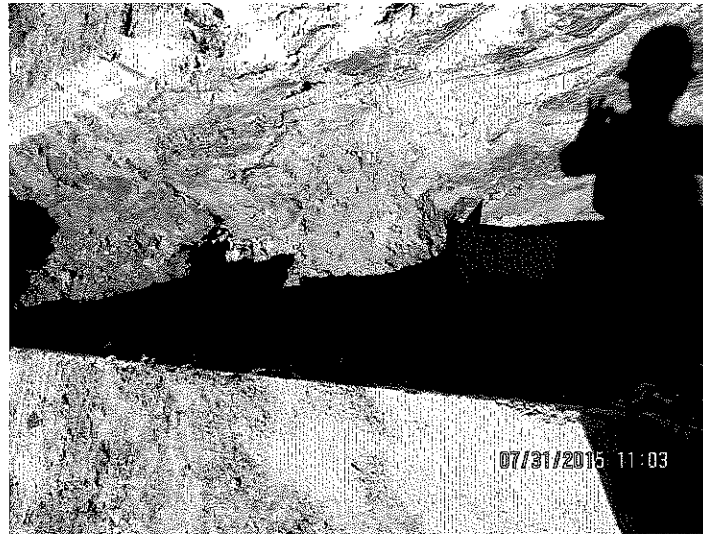
Photo 1: Sample "Pipe Crust-West Pipe @ 81+87" was collected on 7/31/15 at 14:55 from a depth of approx 4 ft. Sample was associated with an unidentified, 24-inch-diameter, N-S pipe 6 ft E of W curb of Dodge Ave. Sample consisted of pipe crust removed from the underside of the 24-in pipe (see red arrow). Brick and glass fragments were present in the backfill around the pipe. This photo shows the large, roughly 24-inch pipe located to the left of shadow. Photo facing NW. By Grover. See exhibit B-5 for laboratory analyses

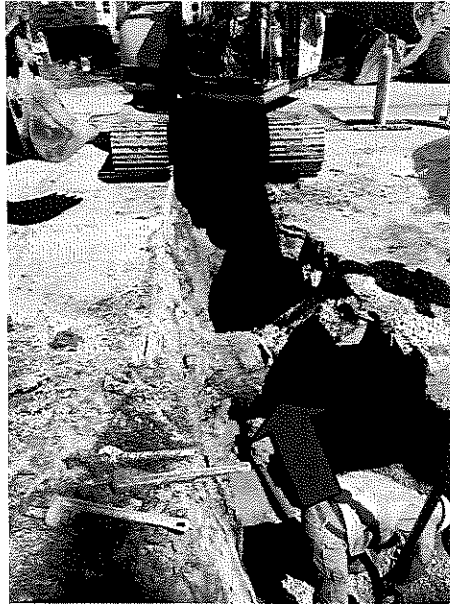
Photo 3: Sample “Exterior pipe crust, 78+95+4E/4” was collected at 8/12/15 at 13:00 from a depth of 4 ft. Sample was associated with an unidentified, 24-inch-diameter N-S pipe 4 ft E of W side of Dodge. Sample consisted of crust collected from the west side of the 24-in pipe (see red arrow). Photo shows the 24-inch pipe, between the worker and excavator, traversing the E-W excavation for the Dawes School 2-in supply lateral. Pipe surrounded by brown sand fill. Photo facing east. By Kramer. See exhibit B-5 for laboratory analyses.

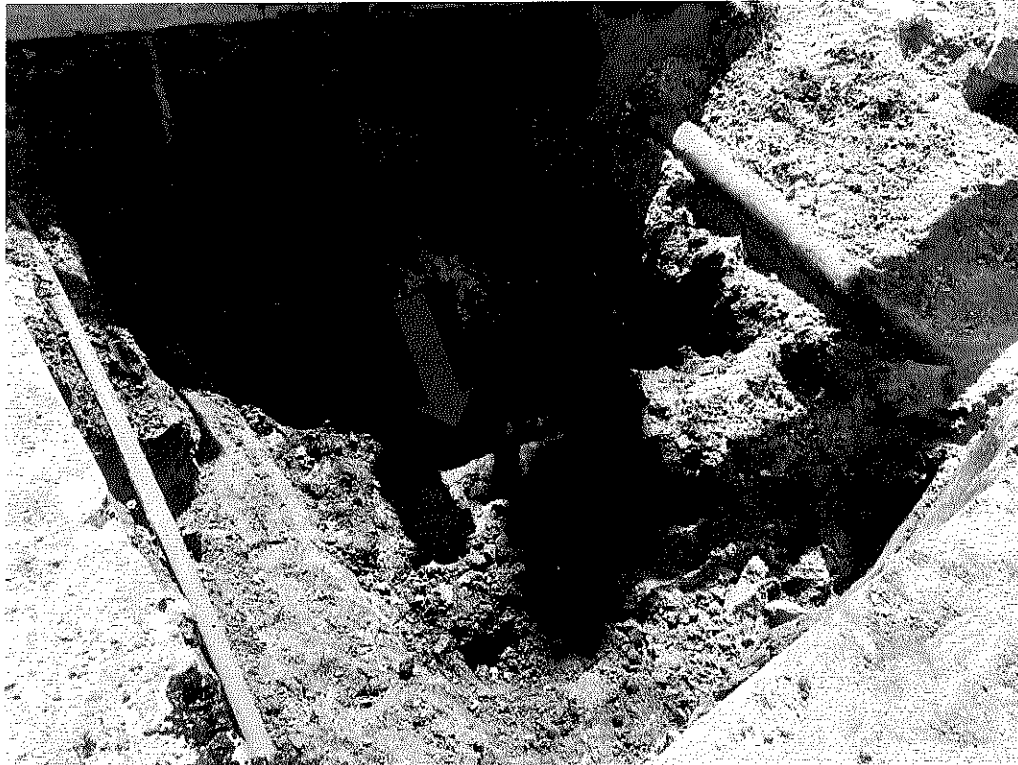
Photo 1: Sample 84+45-6.5' collected on 7/21/15 at 10:40 am from a depth of 6.5 ft. Sample is associated with the 10-inch N-S water main (now abandoned) running down the center of Dodge Ave. Sample taken from soil adjacent to main on the east side. This photo shows the sample area just after sampling. Photo facing to the ESE. By Kollasch. See exhibit B-5 for laboratory analyses

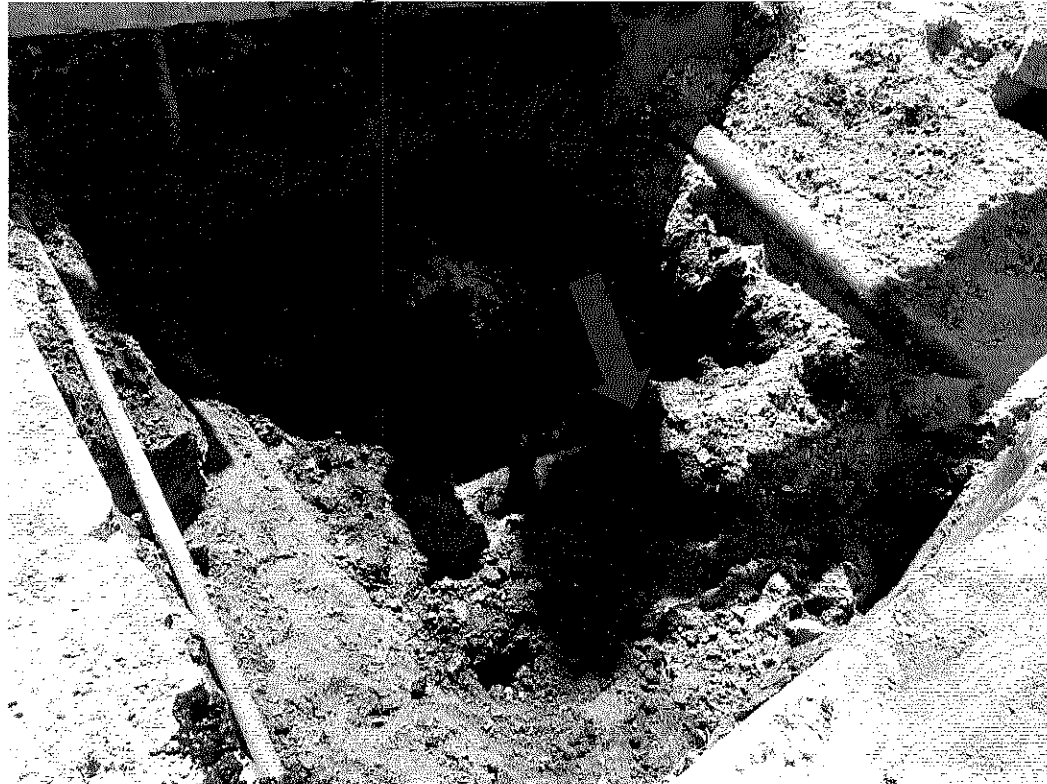
Photo 2: Sample “Pipe Crust 84+26” was collected on 7/24/15 at 8:55 am from a depth of 7 ft. Sample is associated with a 10-inch N-S water main (now abandoned) running down the center of Dodge Ave. Sample consists of black pipe crust collected from the underside of the pipe. This photo shows the approximate location of the crust sample, approximately 2 feet north of the water valve (seen in the upper right corner of the photo). Photo facing SE. By Kollasch. See exhibit B-5 for laboratory analyses

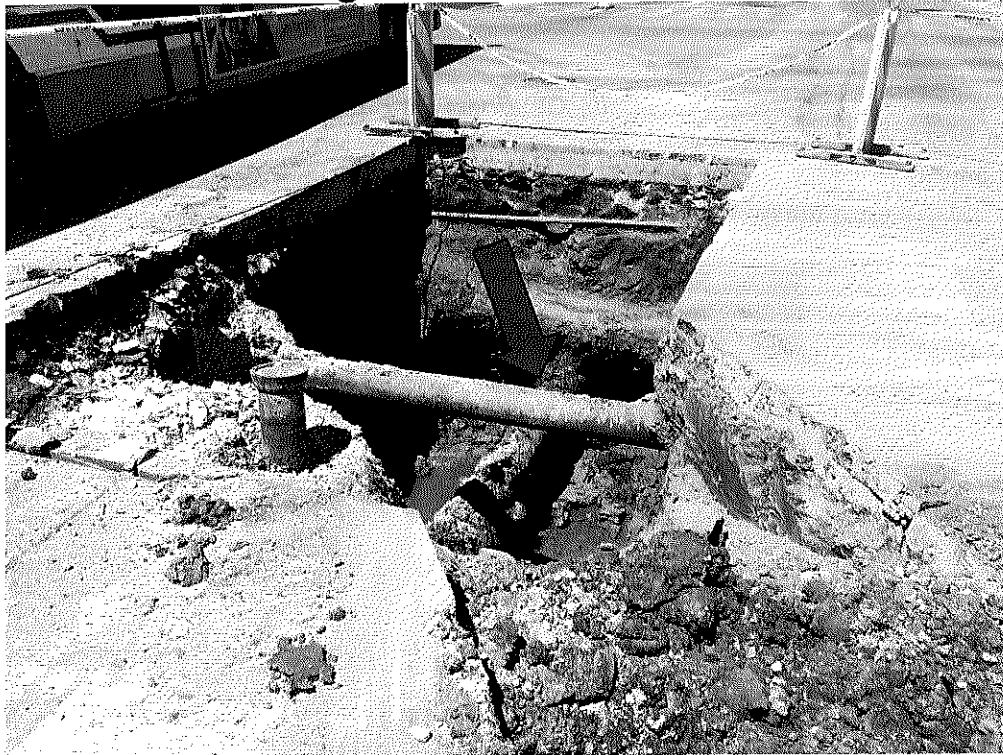
Photo 3: Sample “Pipe Crust 84+45” was collected on 7/24/15 at 10:50 am from a depth of 7 ft. This sample is associated with a 10-inch-diameter, N-S water main (now abandoned) running down the center of Dodge Ave. Sample consists of a pipe crust collected from the exterior of a water-main segment cut from the 10-inch N-S main. Photo shows the approximate location of the pipe segment that was removed from the deepest pipe in the excavation and sampled. Photo facing NNW. By Kollasch. See exhibit B-5 for laboratory analyses

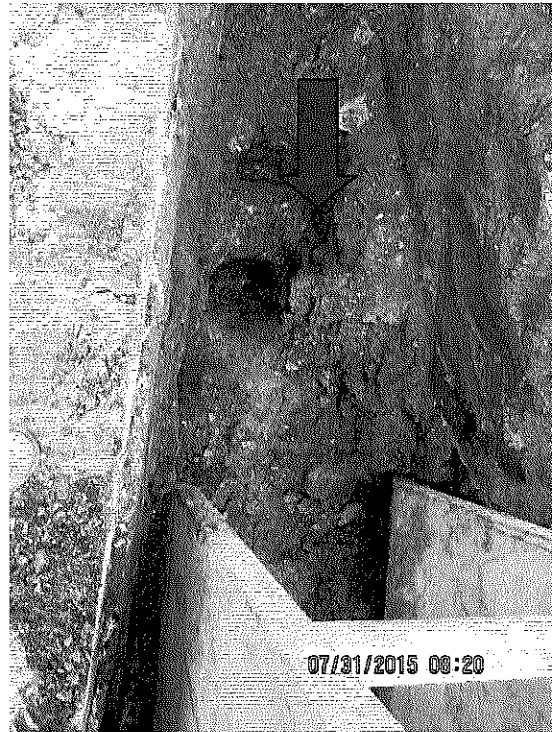
Photo 4: Sample “Soil @ 81+87' Above Water Main” was collected on 7/31/15 at 8:40 am from a depth of 5.5 ft. This sample was associated with a 10-inch-diameter, N-S water main (now abandoned) running down the center of Dodge Ave. The sample consisted of soil from above water main. This photo shows the now-abandoned water main where the soils above were screened and then sampled. Photo facing west. By Grover. See exhibit B-5 for laboratory analyses.

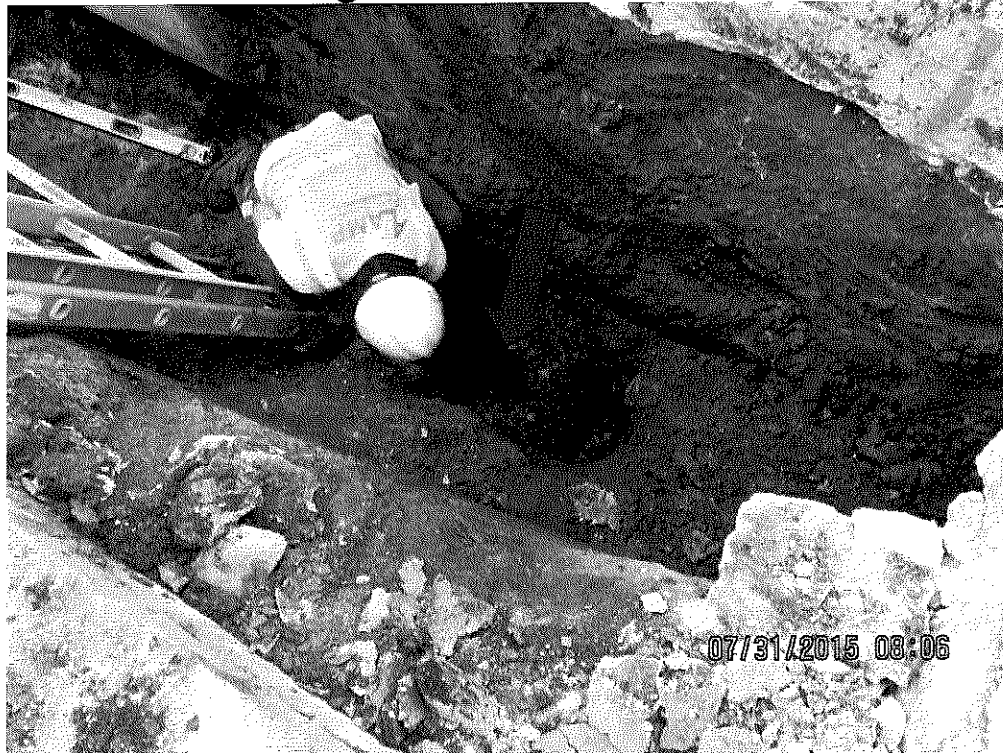
Photo 5: Sample "Soil @ 81+87' Below Water Main" was collected on 7/31/15 at 9:05 am from a depth of approx 7.0 feet. This sample was associated with a 10-inch N-S water main (now abandoned) running down the center of Dodge Ave. This sample consists of soil collected from below water main. This photo shows A-Lamp personnel digging soil from under the now-abandoned water main for sampling. Photo facing NW. By Grover. See exhibit B-5 for laboratory analyses.

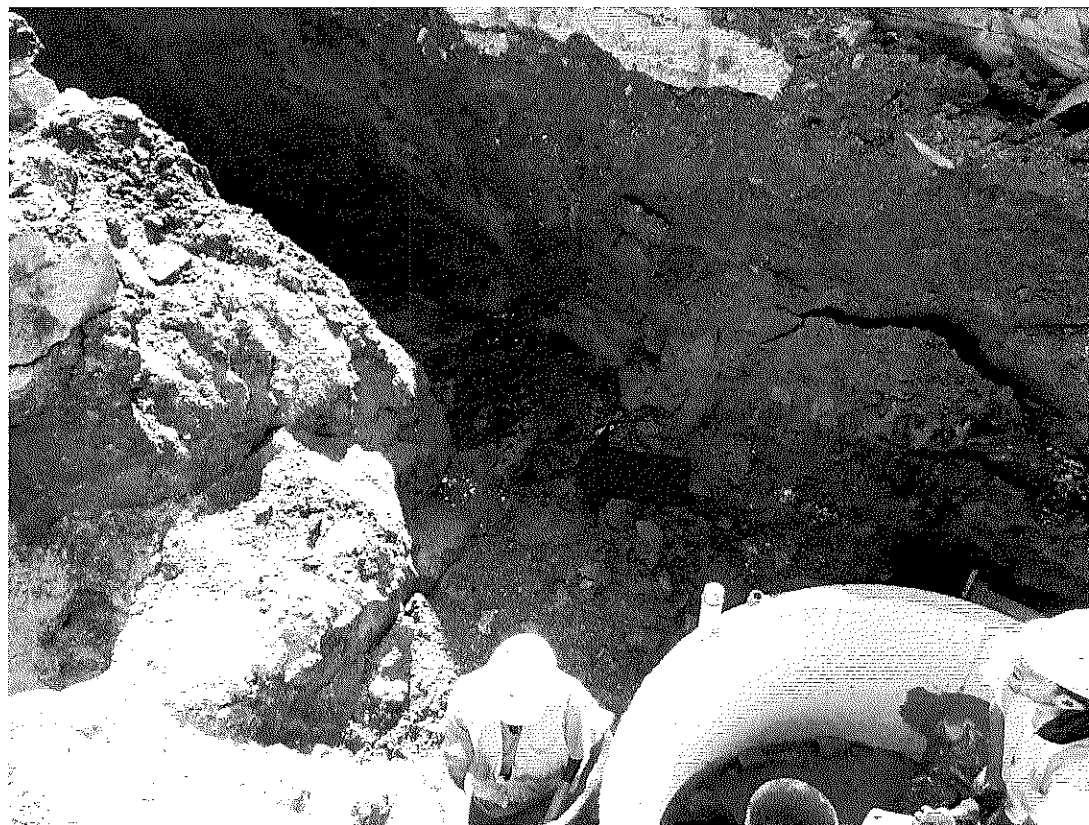
Photo 6: Sample, "78+8" was collected on 8/3/15 at 16:00 at a depth of 7 ft. This sample was associated with an 8-inch OD water main running east-west on Kirk St. This sample consisted of soil from below the Kirk Street water main. This photo shows the water main and the sample location. Sample collected by digging below the pipe from the north. Photo facing SW. By Kollasch. See exhibit B-5 for laboratory analyses.

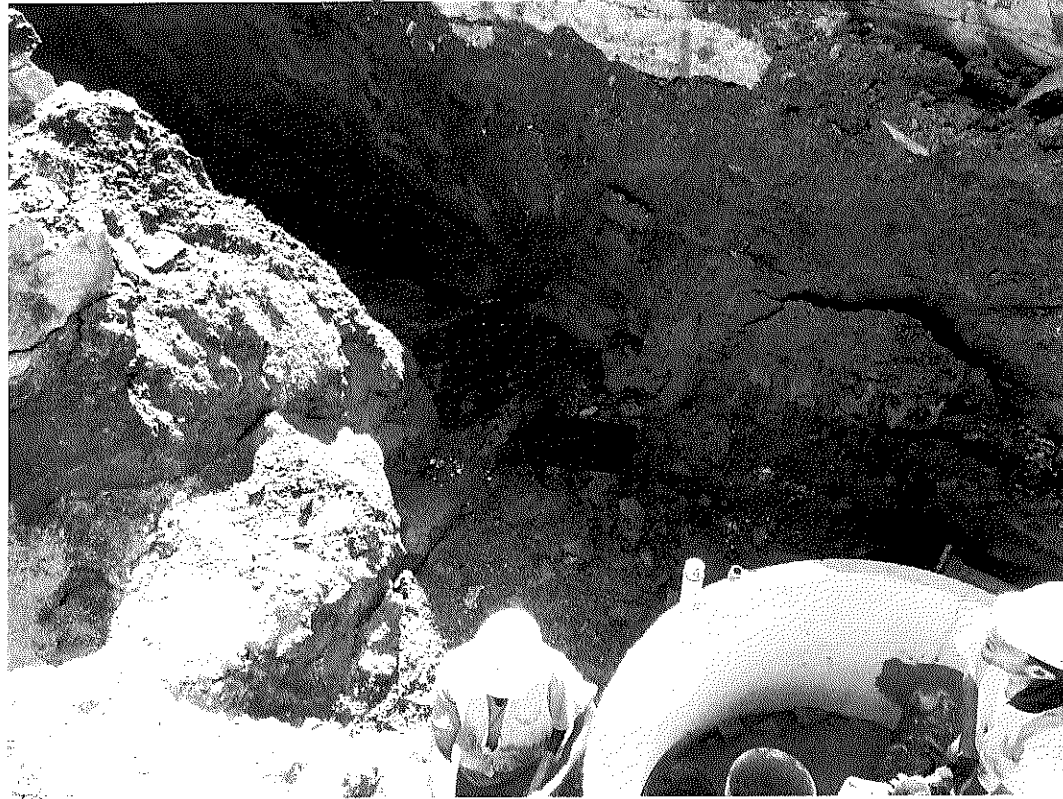
Photo 7: Sample “78+8 Pipe Crust” was collected on 8/3/15 at 16:05 from a depth of 6 ft. This sample was associated with at 8-inch OD water main running east-west on Kirk St. The sample consists of pipe crust scrapped from the Kirk Street water main. This photo shows the scar at the point the crust was removed. Photo facing SW. By Kollash. See exhibit B-5 for laboratory analyses. See exhibit B-5 for laboratory analyses.

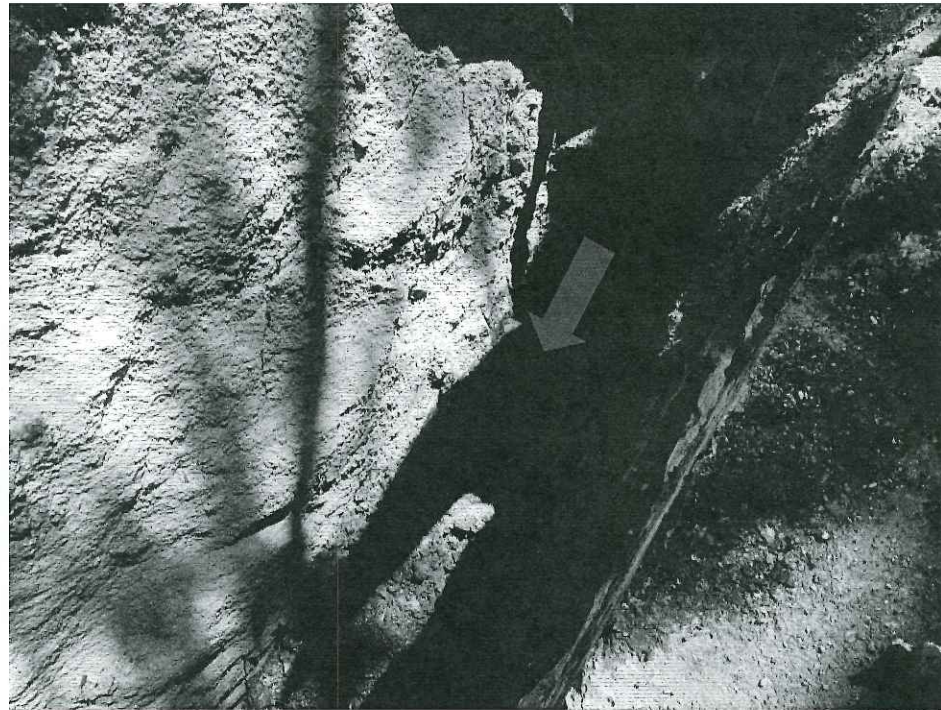
Photo 8: "Sample "74+65+16W/8"" was collected on 8/6/15 at 9:30 from a depth of 8 ft. The sample was associated with a 10-inch-diameter, N-S water main (now abandoned) running down the center of Dodge Ave. This sample consisted of soil collected from above the main. This photo shows the N-S main (in shadow) crossing the base of this E-W excavation for the Levy Center 8-in water lateral (see red arrow). Photo facing NE. By Kramer. See exhibit B-5 for laboratory analyses.

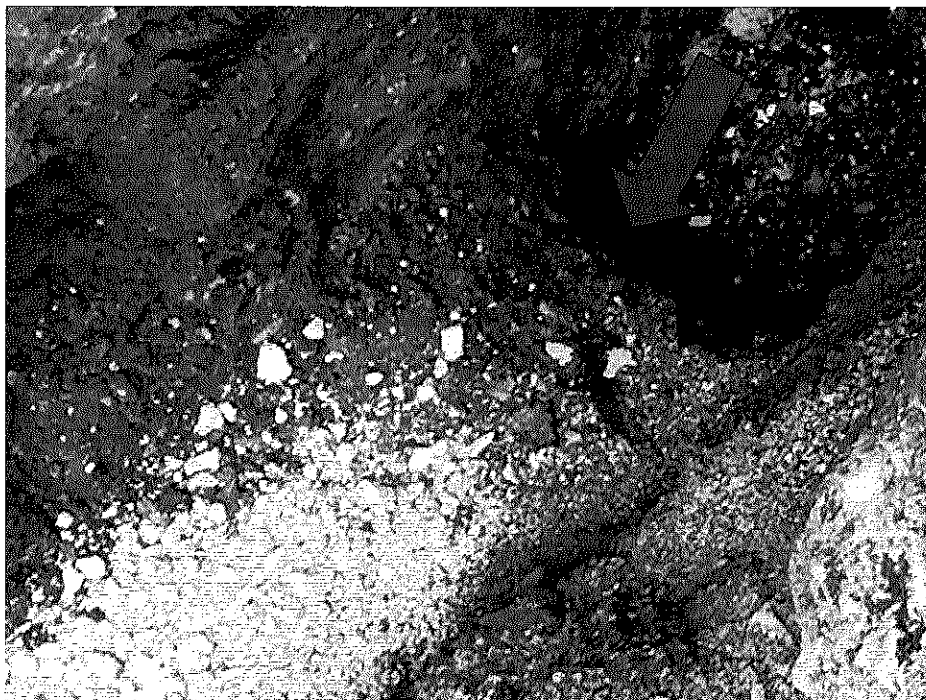
Photo 10: Sample “78+95+24W/6” was collected on 8/12/15 at 11:25 at a depth of 6 ft in the E-W trench for the 2-in water supply lateral for the Dawes School. Sample was associated with a 10-inch diameter, N-S water main (now abandoned) running down the center of Dodge Avenue. Sample consisted of dark-colored soil collected adjacent to the main. Photo facing SW. By Kramer. See exhibit B-5 for laboratory analyses.

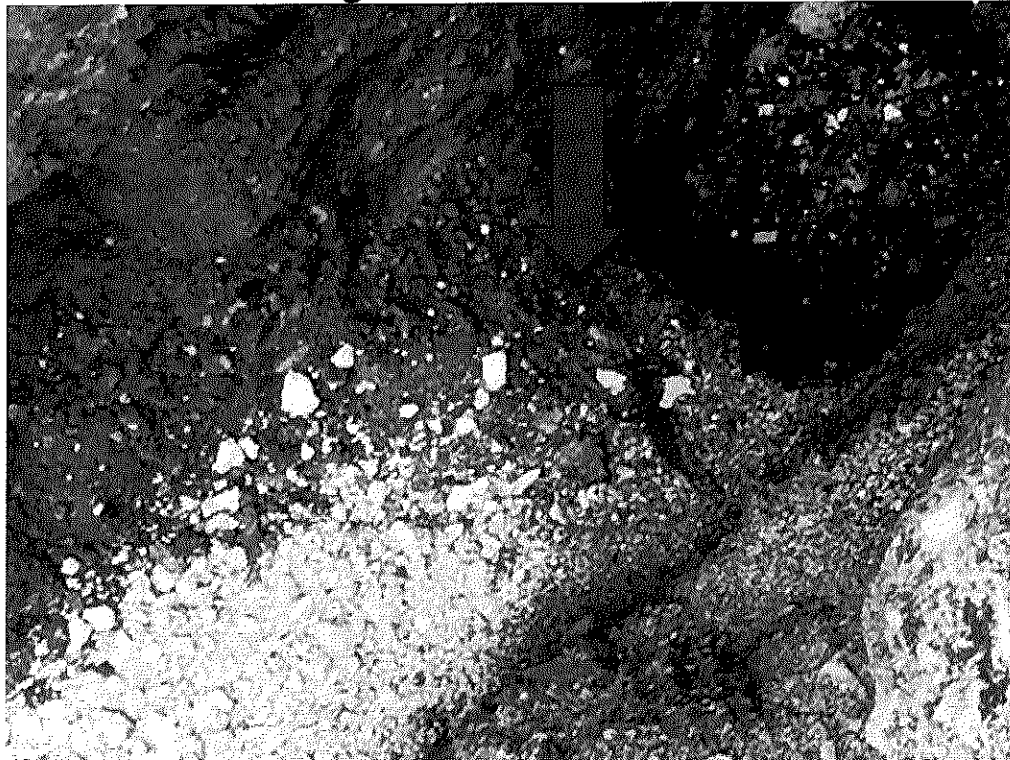
Photo 11: Sample “Exterior pipe crust 78+95+24W/6” was collected on 8/12/15 at 11:25 in the E-W trench for the 2-in water supply lateral for the Dawes School. Sample was associated with the 10-inch-diameter, N-S water main running down the center of Dodge Ave (now abandoned). Sample consisted of black silty sand to gray clayey silt crust scrapped from the water main (see red arrow). Hydrocarbon odor noted. Photo shows 10-inch-diameter main in the upper-right corner (see red arrow). Photo facing SW. By Kramer. See exhibit B-5 for laboratory analyses.

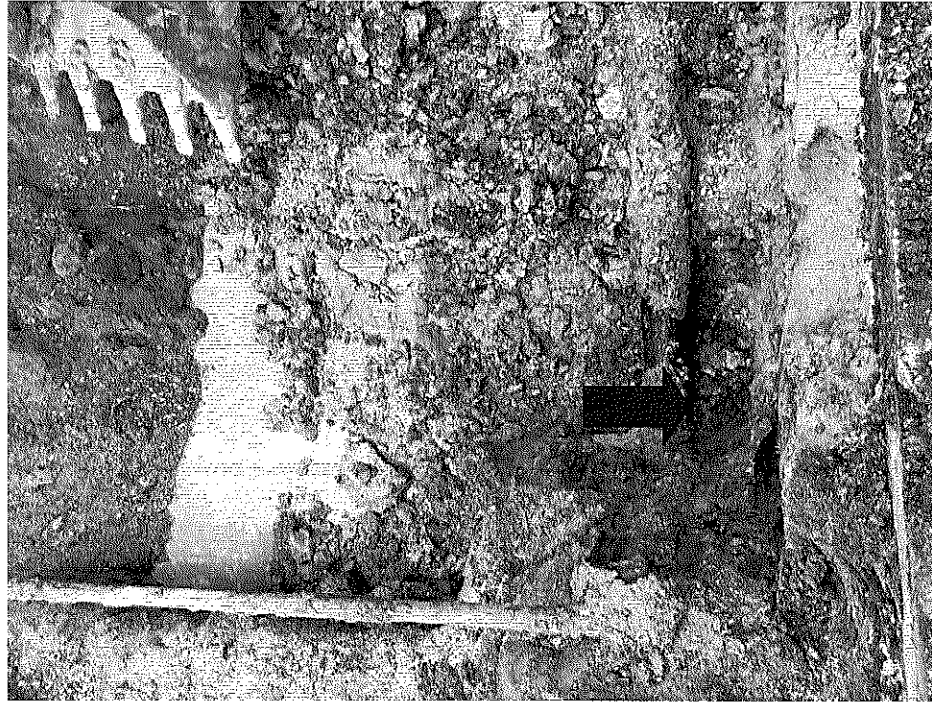
Photo 12: Photo “78+10/7” was collected on 8/18/15 at 9:55 from a depth of 7 ft. Sample is associated with an 8-inch OD, E-W water main on Kirk Street near intersection with Dodge. Sample consists of dark gray soil from adjacent to the main (see red arrow). Photo shows pooled water (left side), 2-in street-light conduit (pink pipe along bottom), and 8-in main (black pipe on right side). Photo facing west. By Kramer. See exhibit B-5 for laboratory analyses.

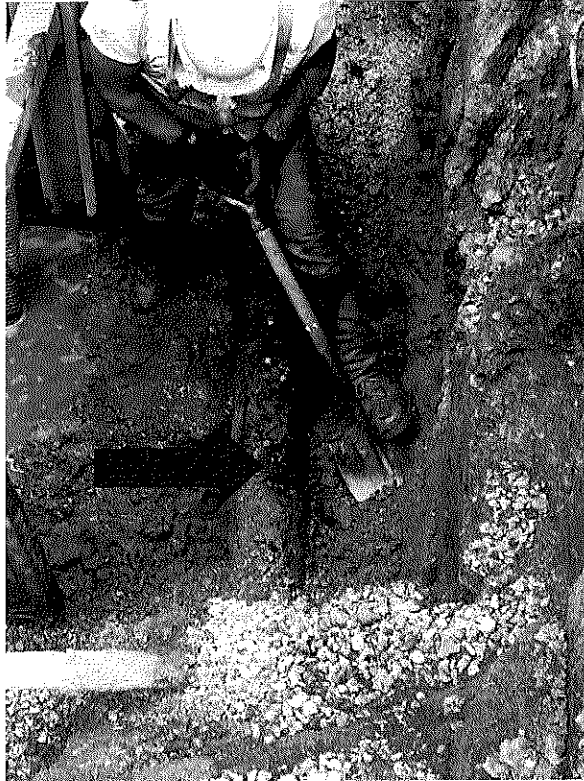
Photo 13: Sample "Exterior Pipe Crust 78+10/7" was collected on 8/19/15 at 10:05 from a depth of 7 ft. Sample is associated with an 8-inch-diam, E-W water main on Kirk Street near intersection with Dodge. Sample consists of crust scraped from the pipe (see red arrow). Photo shows A Lamp workman exposing the pipe. Photo facing east. By Kramer. See exhibit B-5 for laboratory analyses.

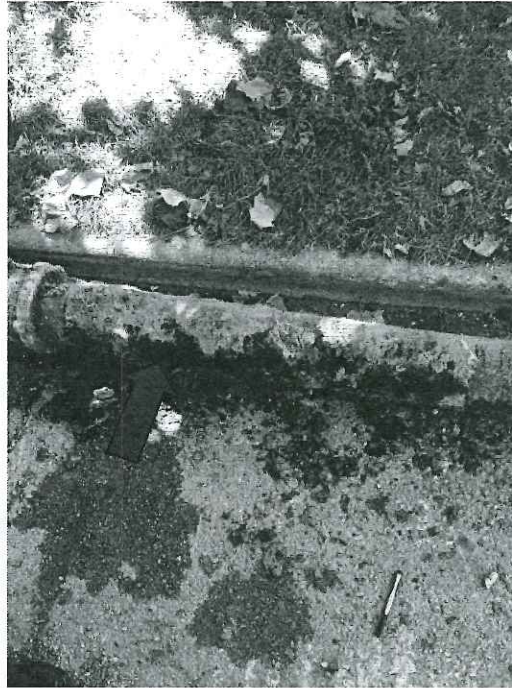
Photo 14: Sample “Exterior Pipe Crust A 78+10/7” was collected on 8/19/15 at 11:20 from a depth of 7 ft. Sample is associated with an 8-inch-diam, E-W water main on Kirk Street near intersection with Dodge. Sample consists of dark, clayey crust scraped from the exterior of the main (see red arrow). Photo facing SSE. By Kramer. See exhibit B-5 for laboratory analyses.

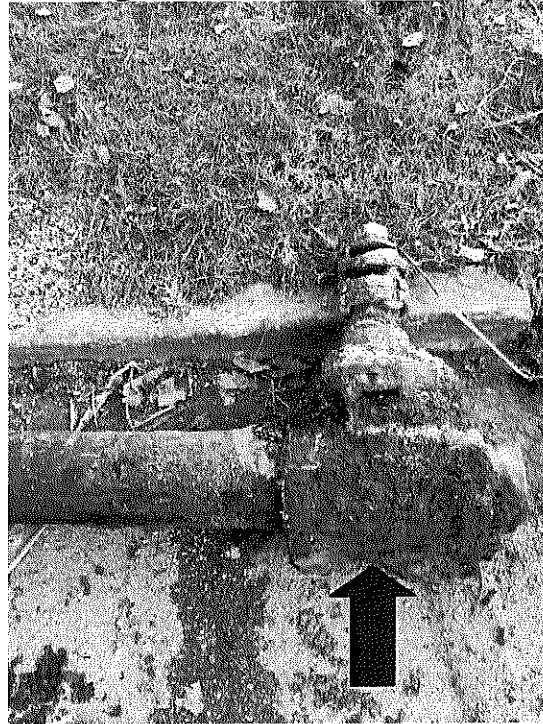
Photo 15: Sample “Valve Crust 78+10/7” was collected on 8/19/15 at 11:35 from a depth of 7 ft. Sample is associated with a valve for the 8-inch E-W Water Main on Kirk near Dodge. Sample consists of crust scrapped from sleeve portion of valve (see red arrow). Photo shows the valve and associated pipe segment before they were cut apart for handling and storage. Photo facing south. By Kramer. See exhibit B-5 for laboratory analyses.

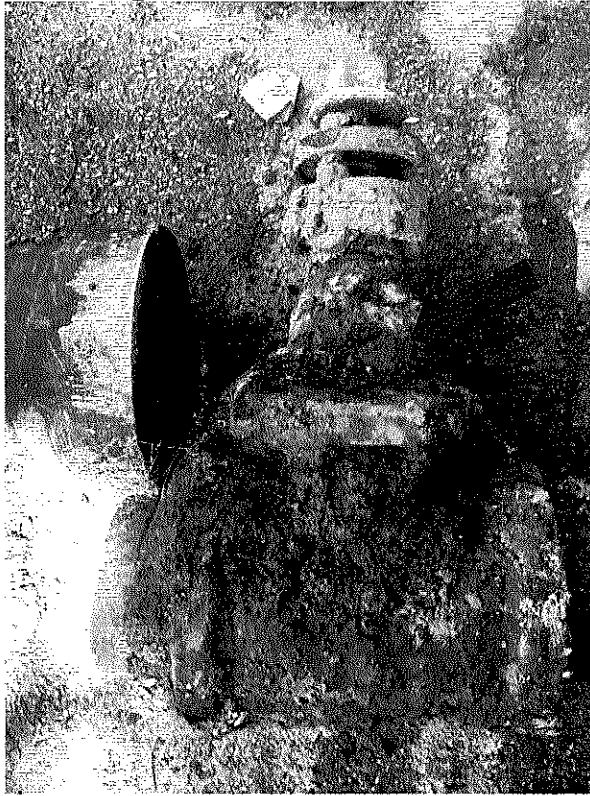
Photo 16: Sample "Top Flange Crust 78+10/7" was collected on 8/19/15 at 13:10 at a depth of 7 ft. Sample is associated with the valve for 8-inch E-W Water Main on Kirk near Dodge. Sample consisted of crust scrapped from the top portion of the valve above the flange (see red arrow). Photo shows valve after it was cut from the pipe to the left. Top of valve in upper half of photo. Photo facing south. By Kramer. See exhibit B-5 for laboratory analyses.

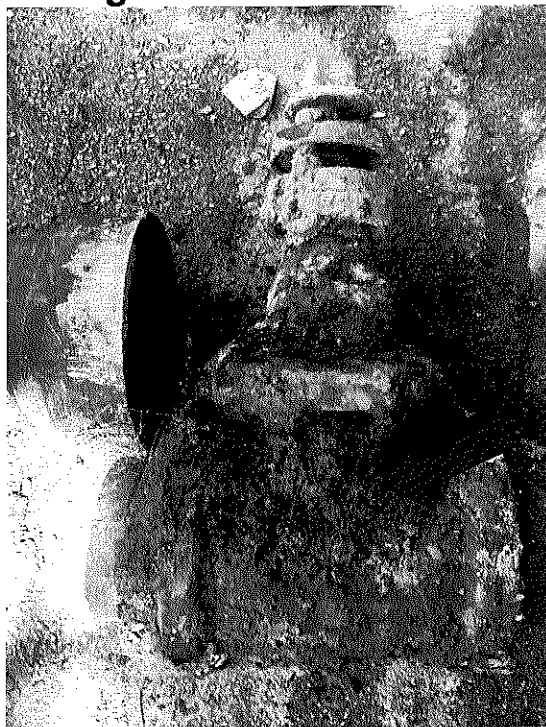
Photo 17: Sample "Bottom Flange Crust 78+10/7" was collected on 8/19/15 at 13:10 from a depth of 7 ft. The sample is associated with a valve for the 8-inch E-W water main on Kirk near Dodge. Sample consists of crust scrapped from below the flange with a chisel (see red arrow). Photo shows valve after it was cut from the pipe to the right. Top of valve in upper half of photo. Photo facing south. By Kramer. See exhibit B-5 for laboratory analyses.

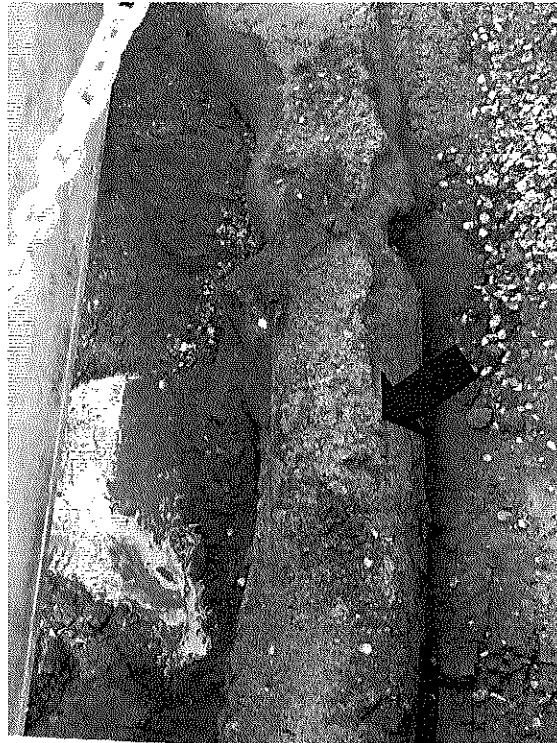
Photo 18: Sample, "Exterior Pipe Crust 71+50/7" was collected on 8/20/15 at 9:30 from a depth of 7 ft. Sample is associated with a 10-inch diam, N-S, water main down center of Dodge (now abandoned). Sample consists of crust scrapped from the main (see red arrow). Photo shows encrusted pipe laying in angled trench at Mulford and Dodge. Photo facing south. By Kramer. See exhibit B-5 for laboratory analyses.

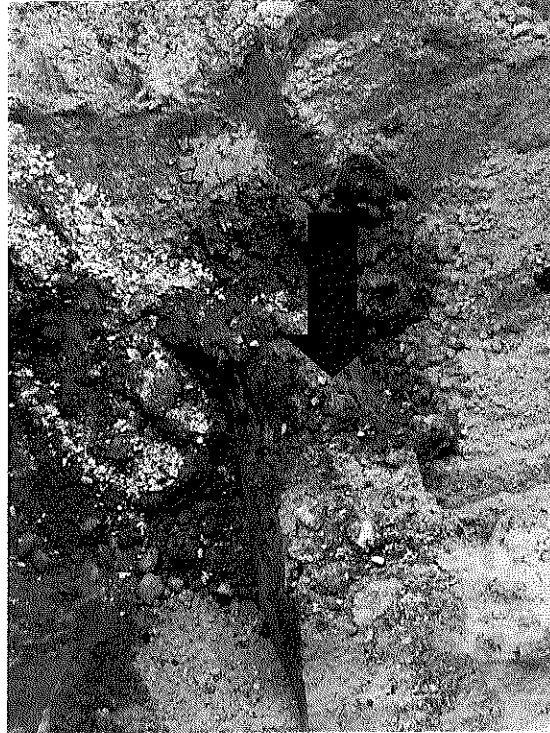
Photo 19: Sample “71+50/7” was collected on 8/20/15 at 10:00 from a depth of 7 ft. Sample is associated with a 10-inch diam, N-S, water main down center of Dodge (now abandoned). Sample consists of gray silty-clay soil collected from above the main. Photo shows the main covered with soil in center of photo (running from top to bottom). Photo facing SSW. By Kramer. See exhibit B-5 for laboratory analyses.

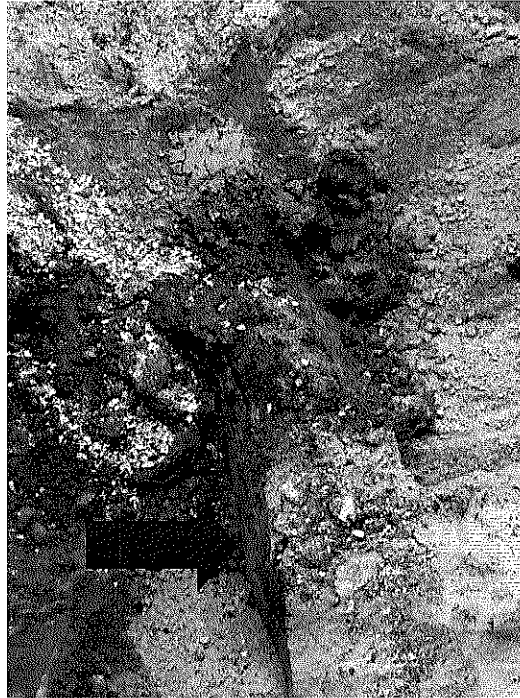
Photo 20: Sample “71+50/8” was collected on 8/20/15 at 10:45 from a depth of 8 ft. Sample is associated with the 10-inch diam, N-S, water main heading down center of Dodge (now abandoned). Sample consisted of gray silty-clay soil collected from below the main (see red arrow). Photo shows the main covered with soil in center of photo (running from top to bottom). Photo facing SSW. By Kramer. See exhibit B-5 for laboratory analyses.

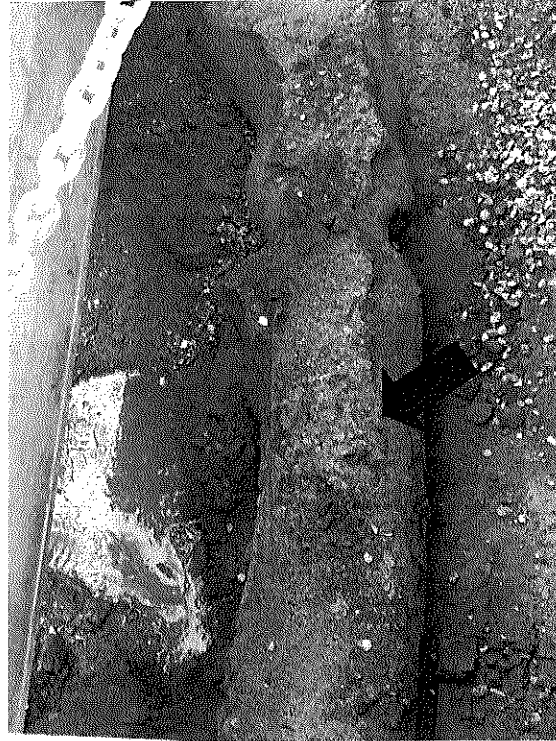
Photo 21: Sample, "Exterior Pipe Crust 71+50/7" was collected on 8/20/15 at 9:30 from a depth of 7 ft. Sample is associated with a 10-inch diam, N-S, water main down center of Dodge (now abandoned). Sample consists of crust scrapped from the main (see red arrow). Photo shows encrusted pipe lying in angled trench at Mulford and Dodge. Photo facing south. By Kramer. See exhibit B-5 for laboratory analyses.

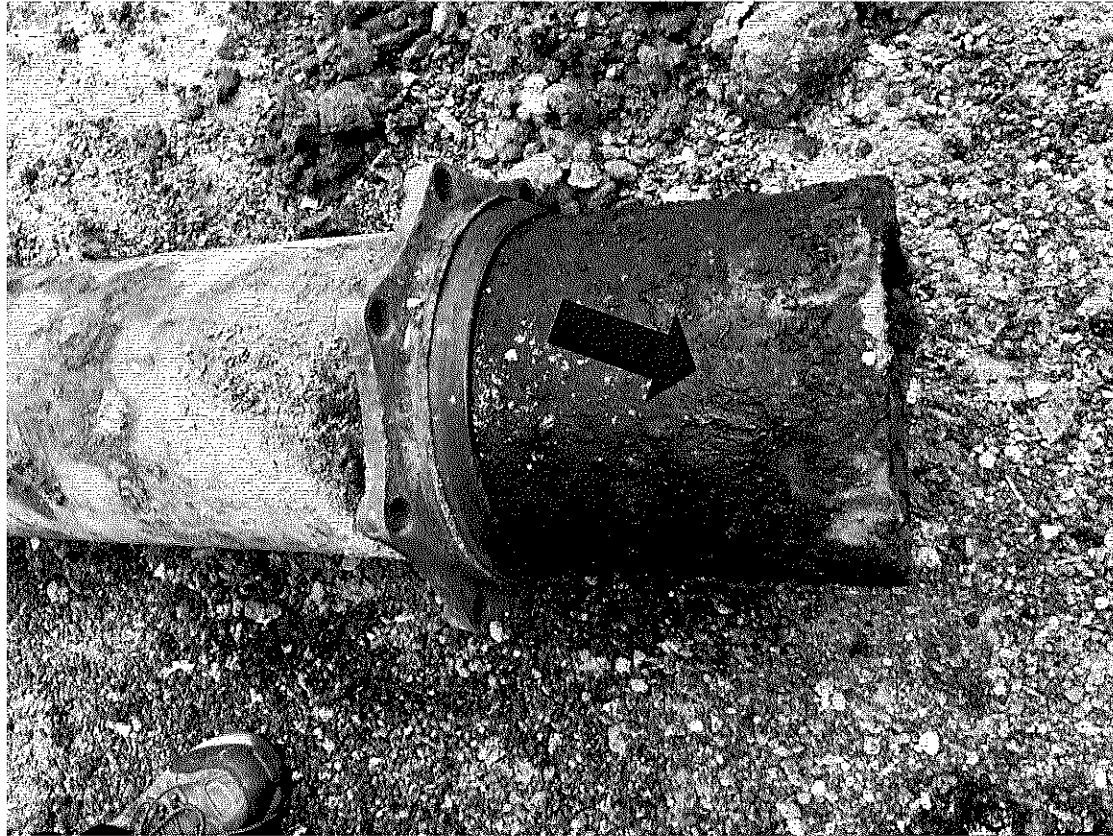
Photo 22: Sample “Exterior Pipe Crust A 71+50/7” was collected on 8/20/15 at 12:40 from a depth of 7 ft. Sample is associated with a pipe joint on the 10-inch-diam, N-S water main down center of Dodge (now abandoned). Sample consisted of a crust sample scrapped from the male portion of a pipe joint. Photo shows a black crust right of the connecting flange and rubber gasket (red arrow). The black section of the pipe is the part that extended inside the adjoining pipe. Photo facing south. By Kramer. See exhibit B-5 for laboratory analyses.

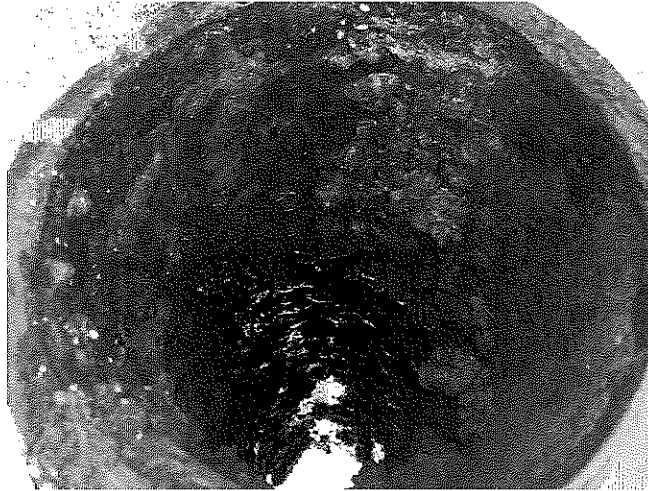
Photo 1: Sample "Interior Pipe Crust 78+10/7" was collected on 8/19/15 at 10:50 from a depth of 7 ft. Sample is associated with an 6-inch, inner diam, E-W water main on Kirk Street near intersection with Dodge. Sample consists of crust scraped from the inside of the water main a section was removed from excavation. Photo shows the crust inside the main. By Kramer. See exhibit B-5 for laboratory analyses.

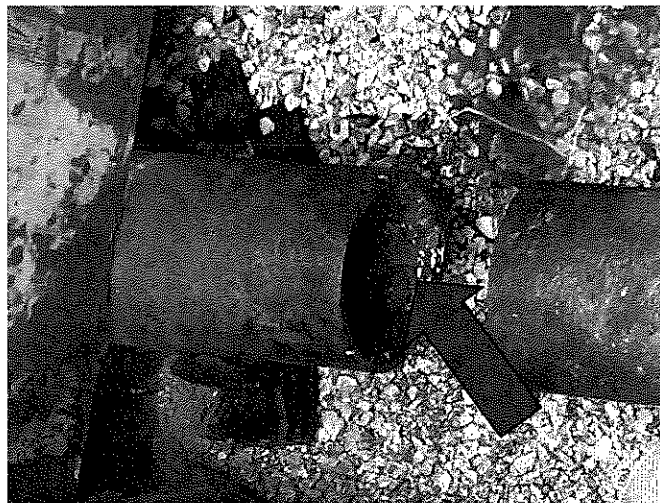
Photo 2: Sample "Interior Pipe Crust 71+50/7" was collected on 8/20/15 at 12:15 from a depth of 7 ft. Sample was associated with a 10-inch inner diam, N-S, water main down center of Dodge (now abandoned). Sample consisted of pipe crust scrapped from the interior of pipe stub protruding from the south wall of the Dodge and Mulford angled excavation. Photo shows cut pipe with red crust inside. Photo facing WSW. By Kramer. See exhibit B-5 for laboratory analyses.
